**Alexandria Site Visit**  
**Robert Reed**  
**March 28, 2006**

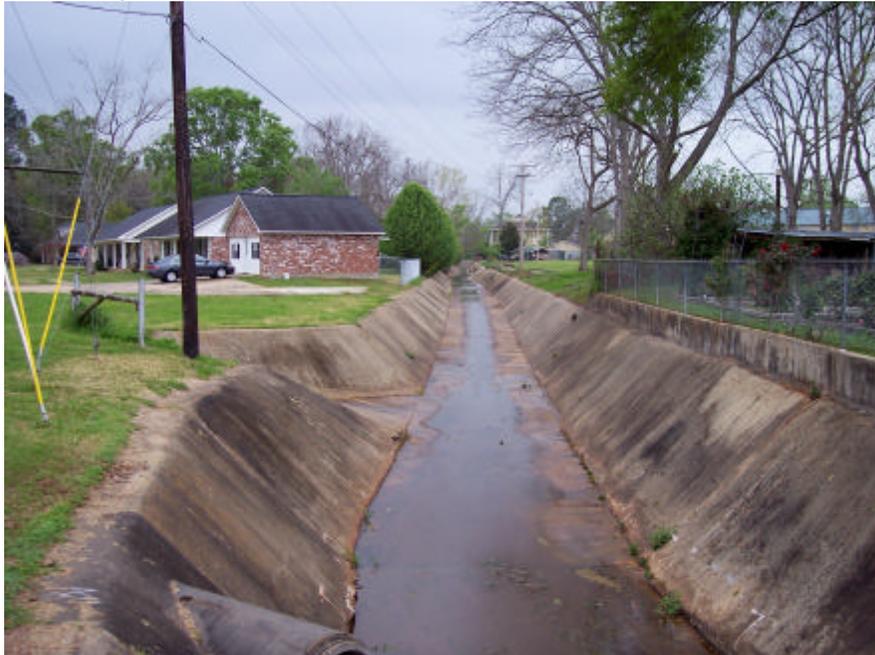
The slope of Horseshoe Bayou does appear to be steeper just upstream of Alden Court, and I did not see any inline structures.

Horseshoe at Alden Court looking upstream

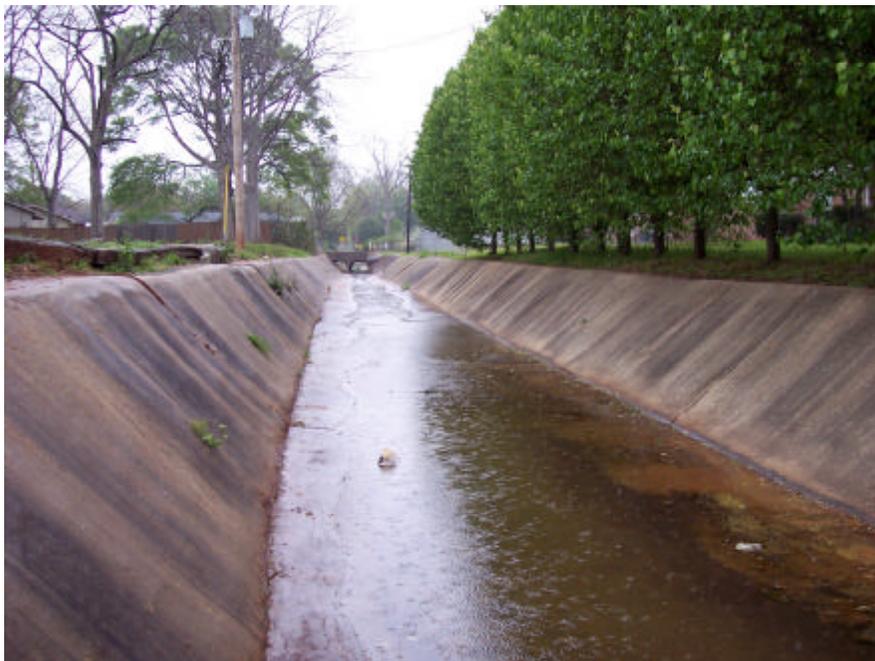
Horseshoe looking downstream at Alden Court

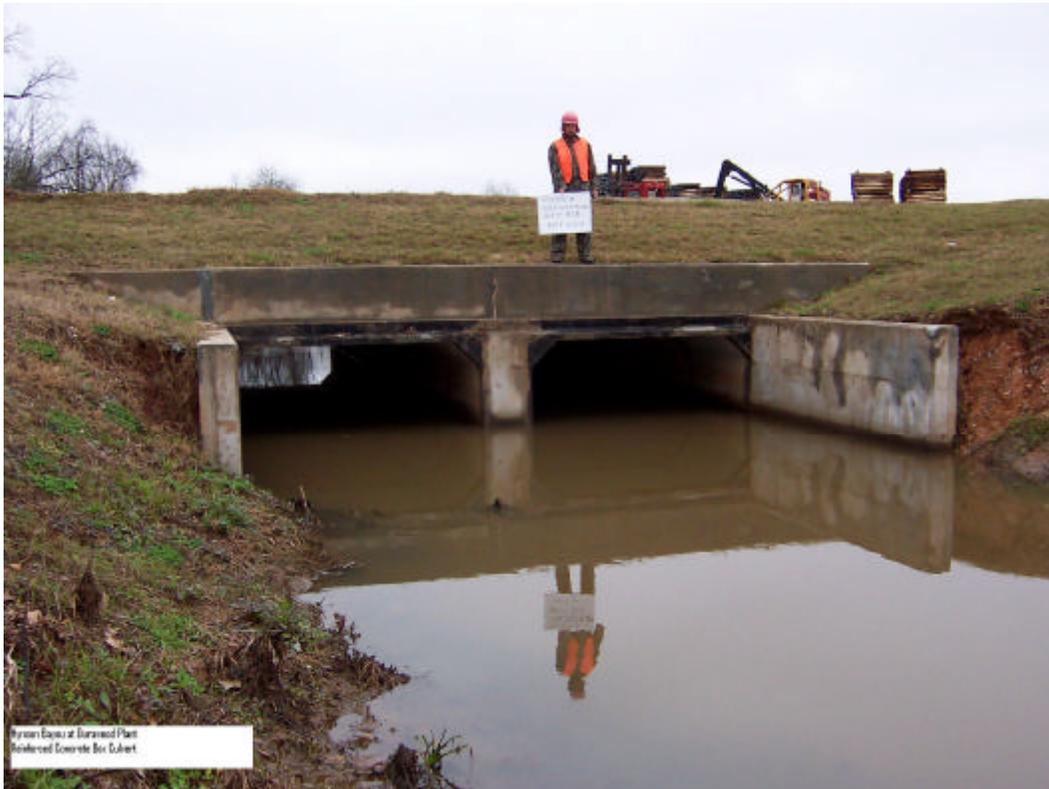
Survey photo of 2 – 9' x 9' RCBC outlet

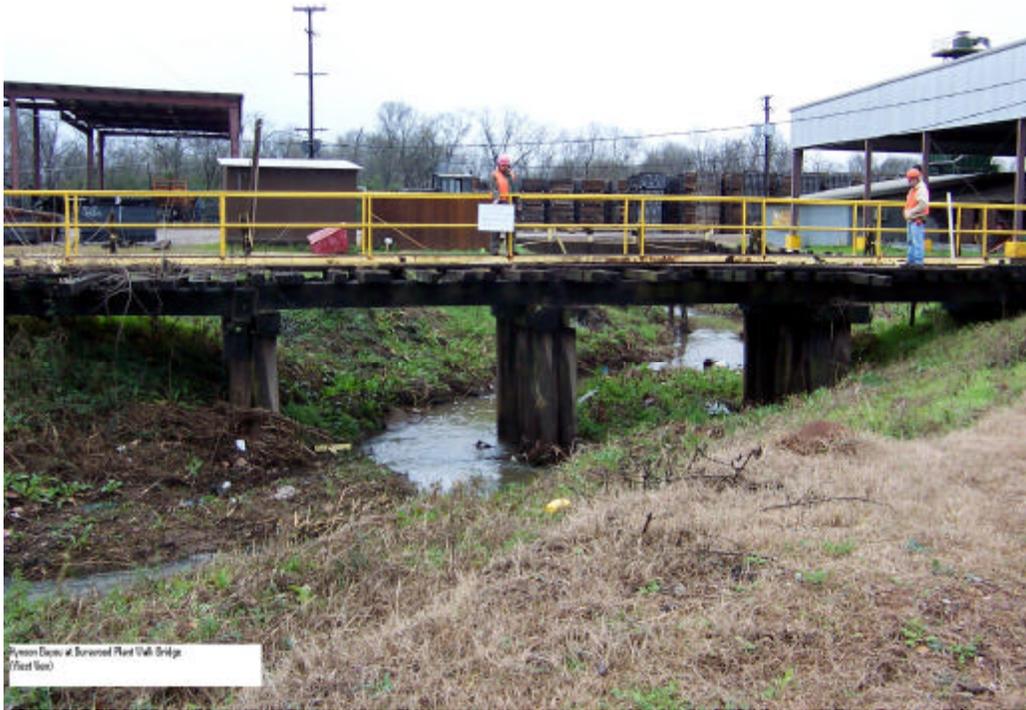
Survey photo of Walkway Bridge from 2 – 9' x 9' RCBC

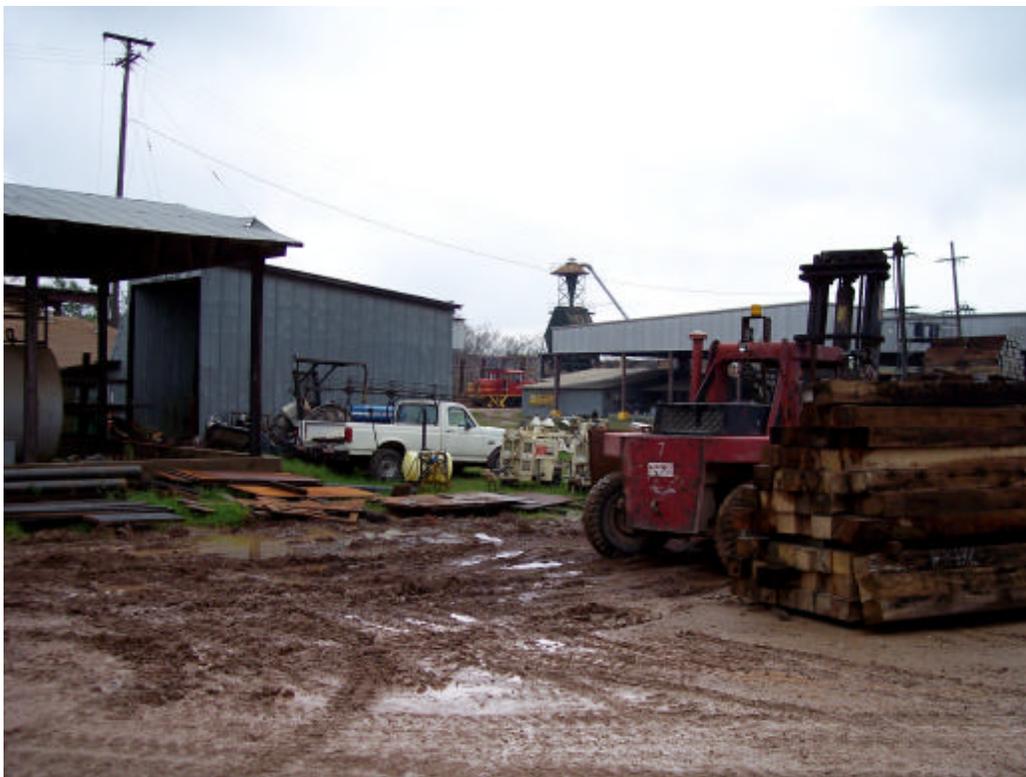
03-28-2006 photo from 2 – 9' x 9' RCBC looking downstream

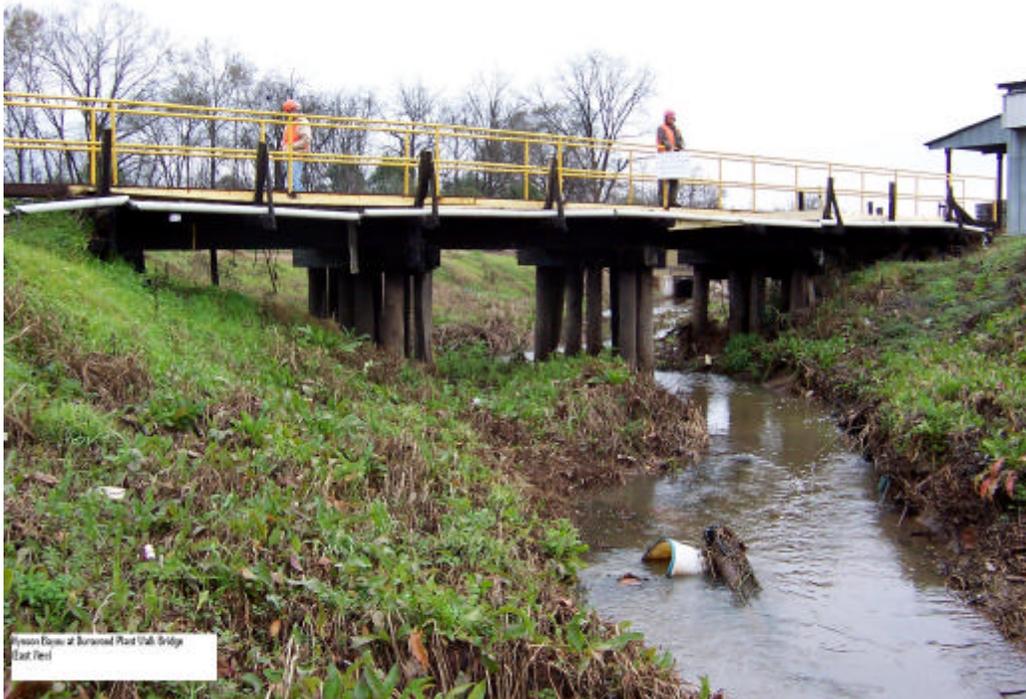
Survey photo from 72" steel pipe of Walkway Bridge with 2 - 9' x 9' RCBC outlet in background

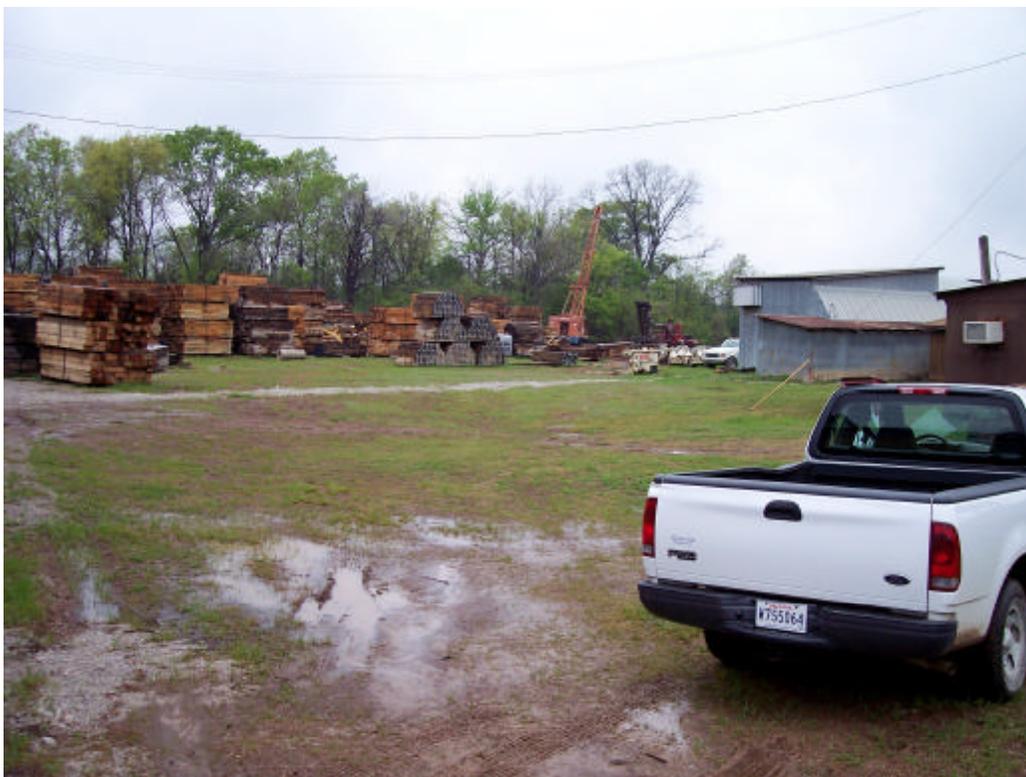
03-28-2006 photo from 72" steel pipe looking upstream

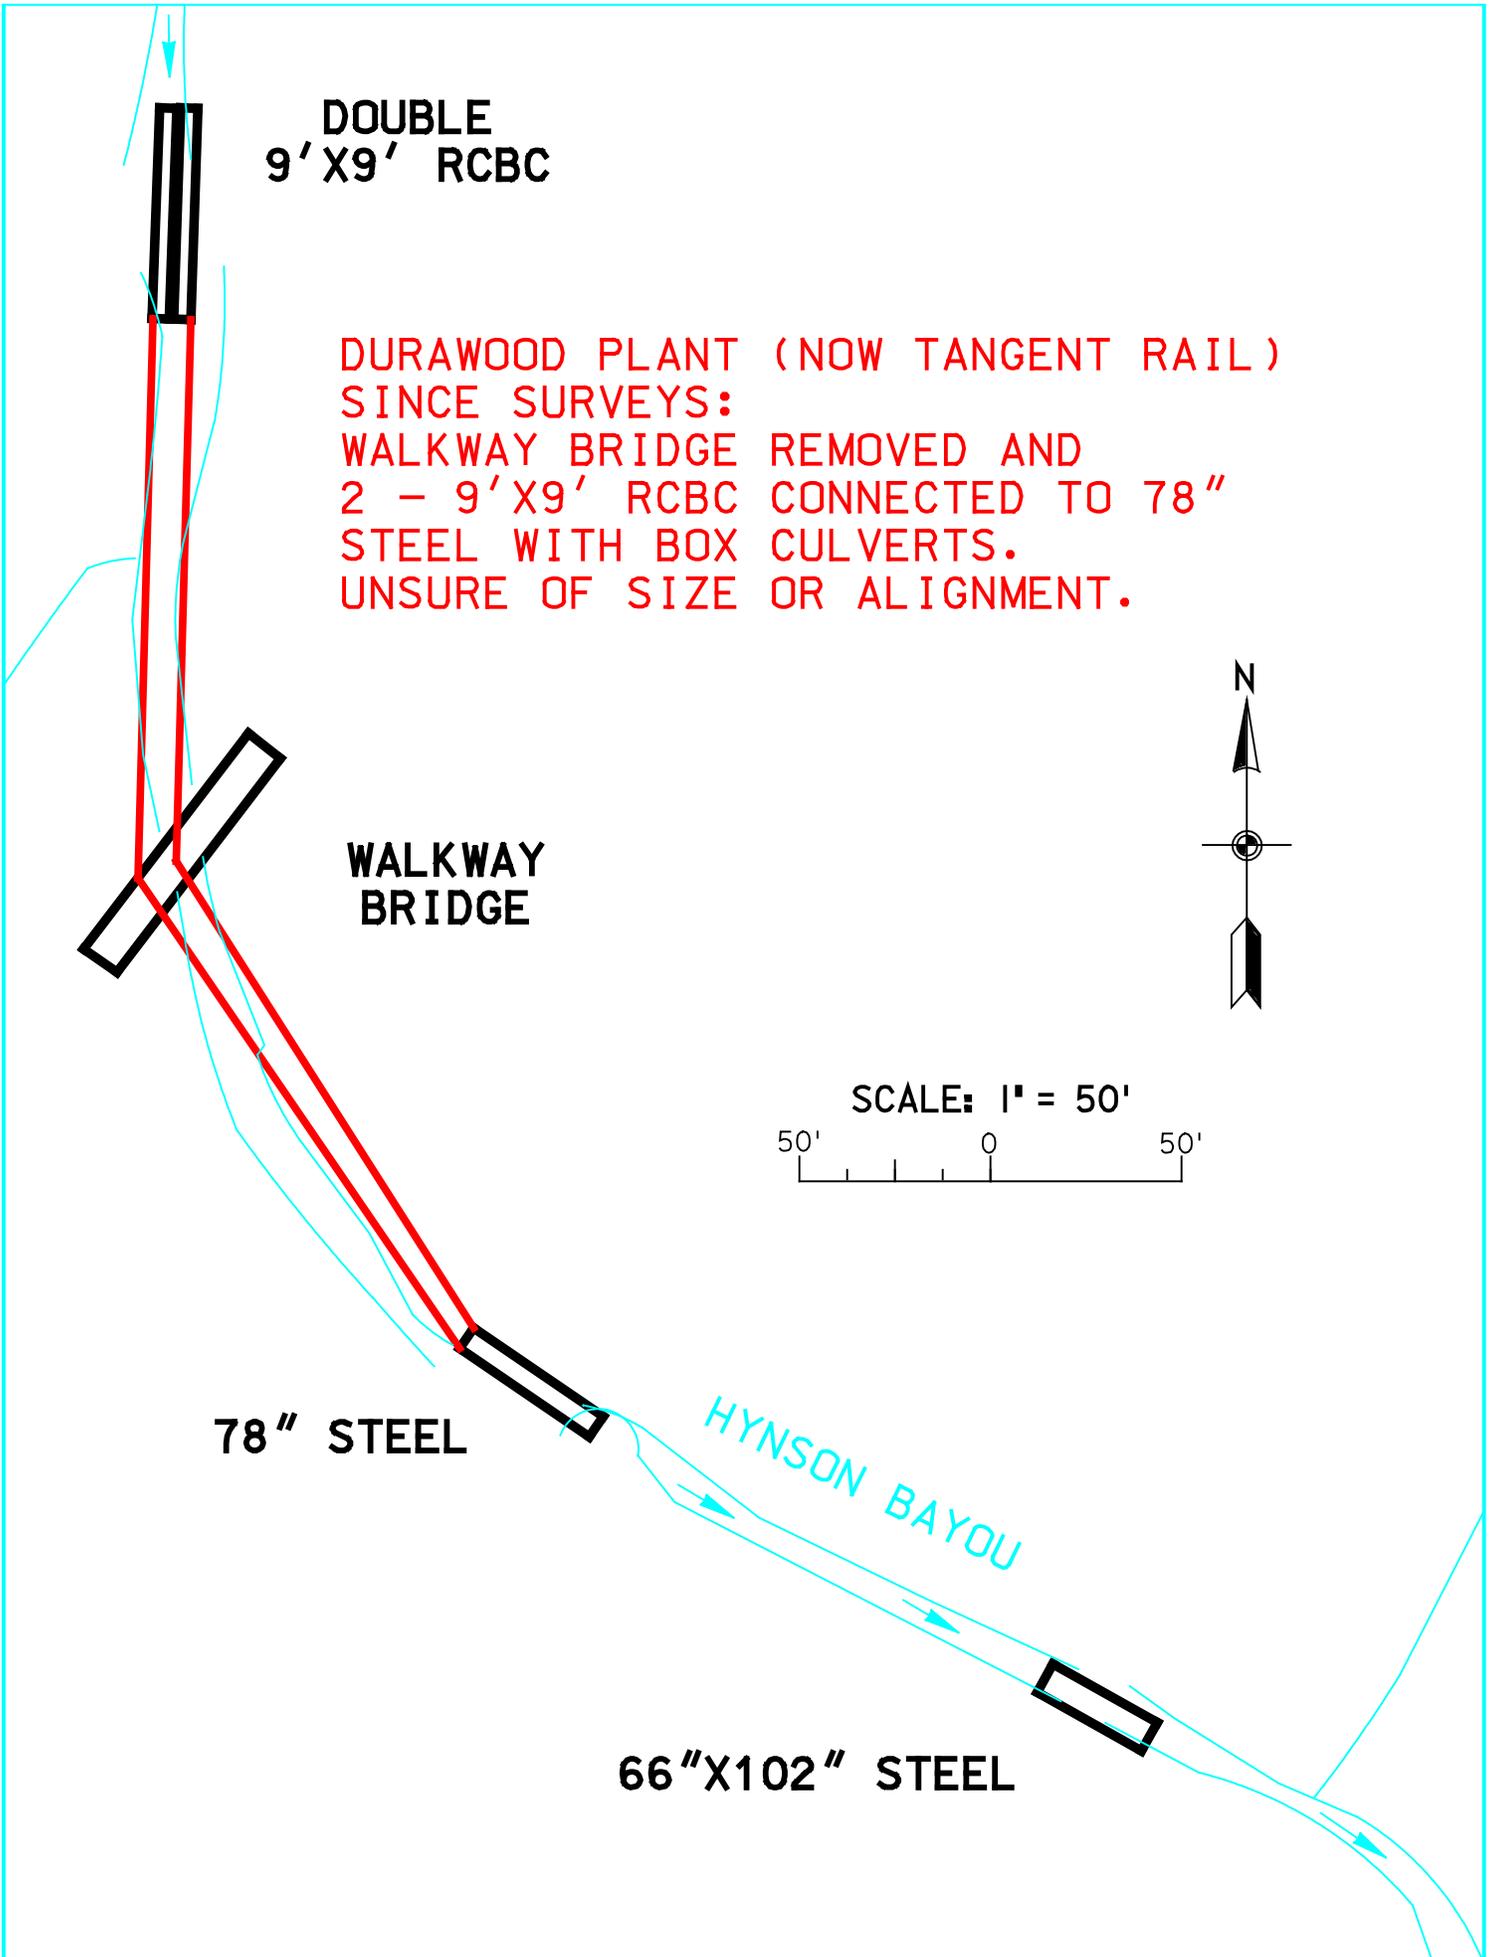
**DURAWOOD PLANT (NOW TANGENT RAIL )  
SINCE SURVEYS:  
WALKWAY BRIDGE REMOVED AND  
2 - 9' X 9' RCBC CONNECTED TO 78"  
STEEL WITH BOX CULVERTS.  
UNSURE OF SIZE OR ALIGNMENT.**

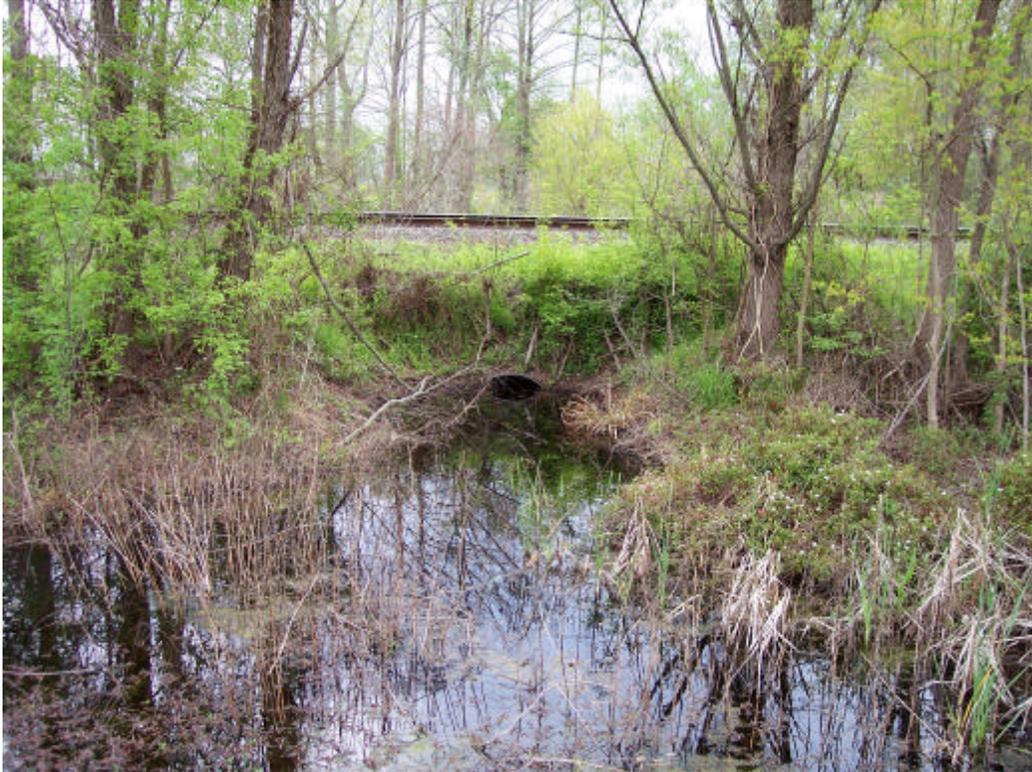
Pipe under railroad at southern end of “oxbow slough” and possible alignment

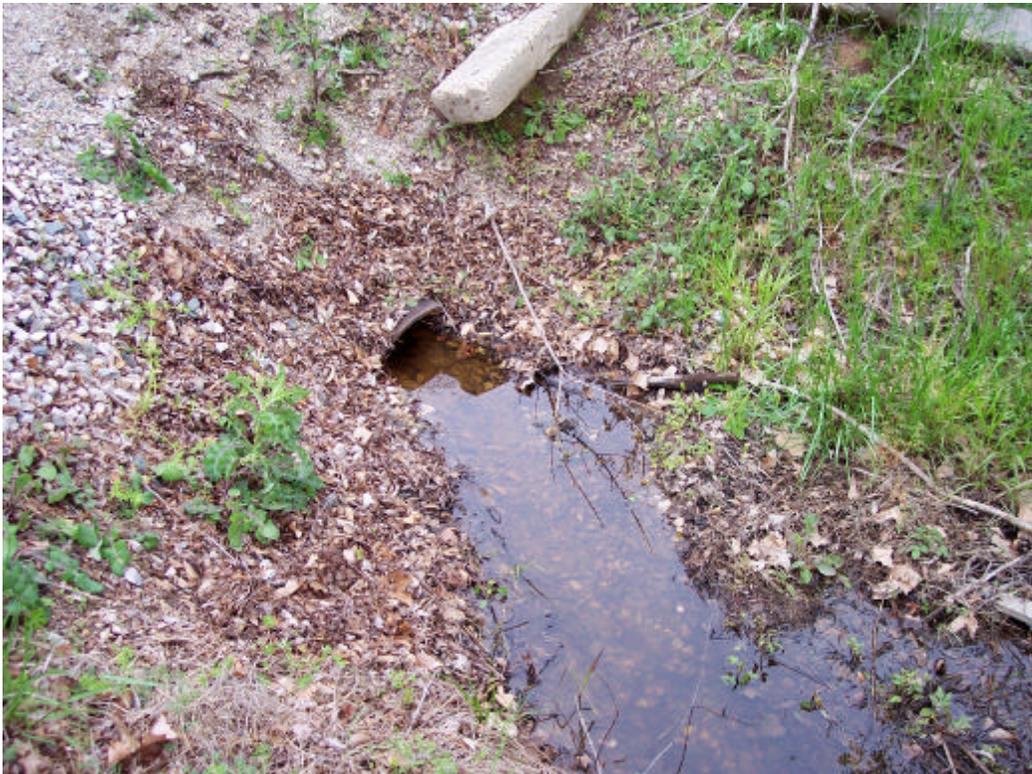
Pipe under railroad at northern end of “oxbow slough”

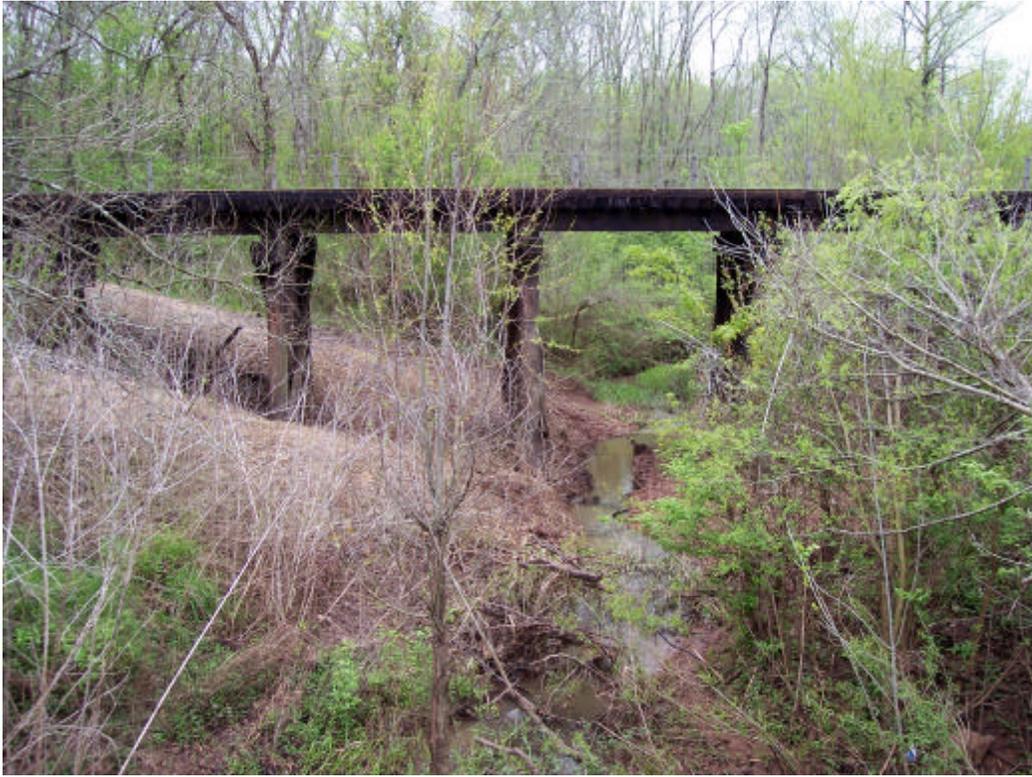
Railroad bridge over Persimmon Bayou

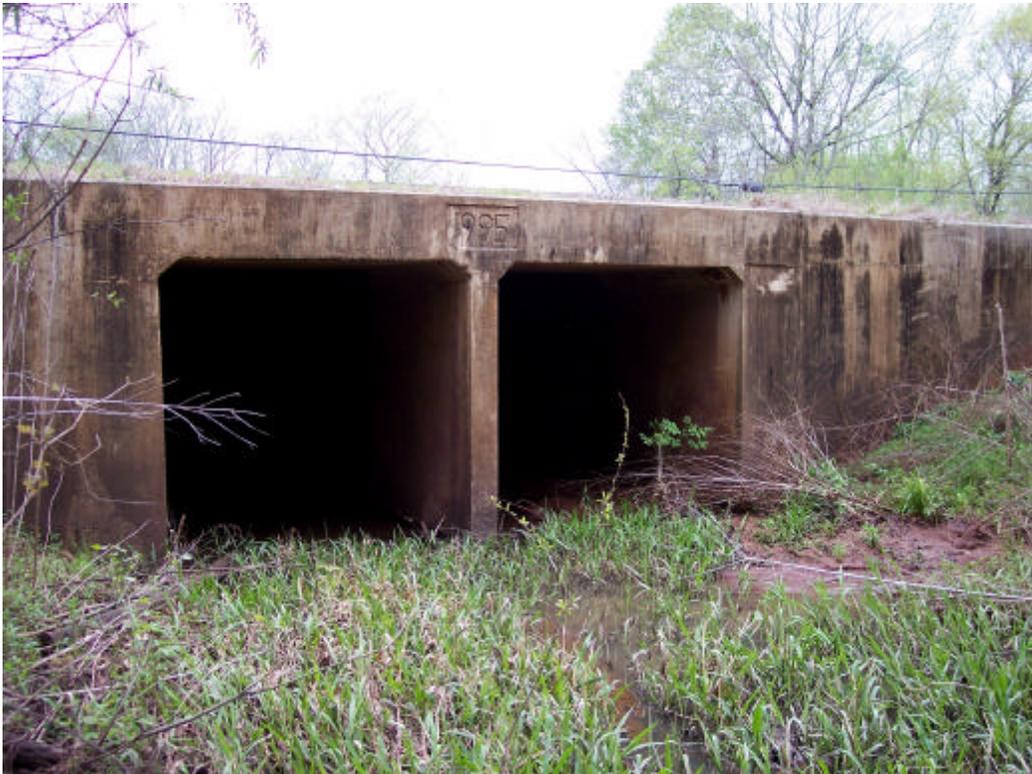
Double 8' x 8' RCBC inlet under Hwy 1 at Persimmon Bayou
