Alexandria to the Gulf Feasibility Study Hynson and Sandy Bayou Drainage

February 2006

HYNSON & SANDY BAYOU PHOTO INDEX

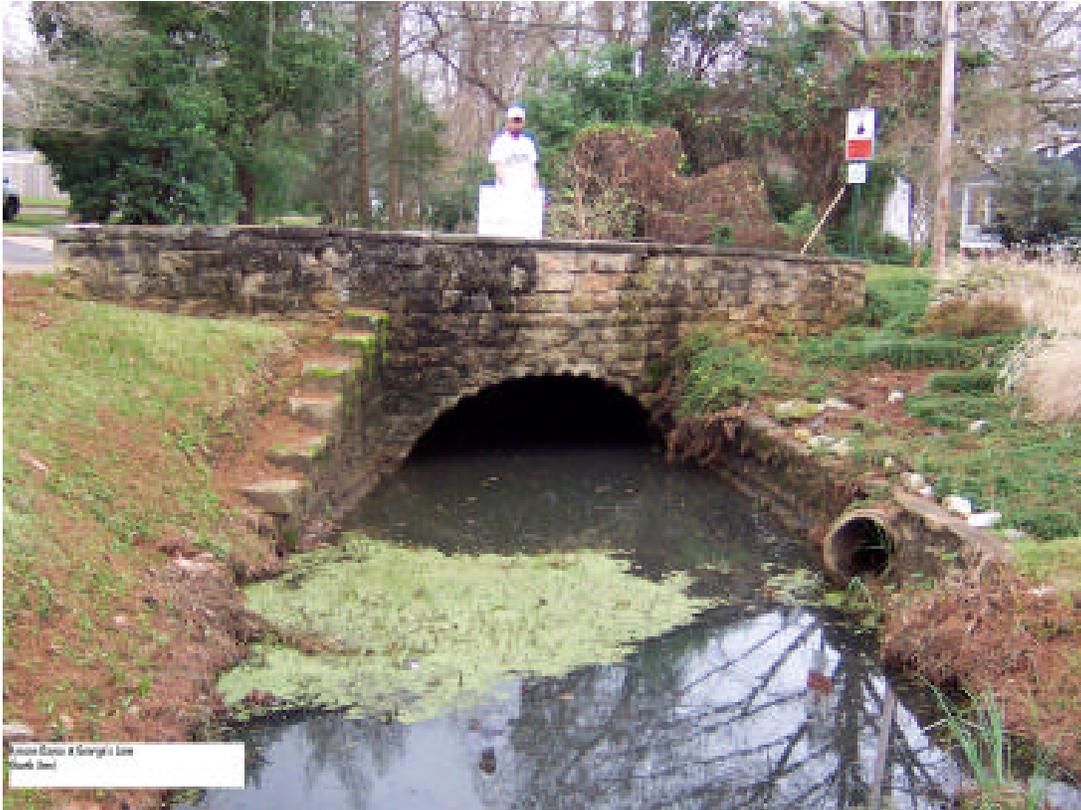
(12A) 2241+50 George's Lane (US View) – 84"x132" CMPA

The upper end of Hynson Bayou appears to have standing water and vegetation creating a sluggish flow and inefficient drainage structures (see pictures 12A, 13A and 14B). Picture 16B shows a bridge at Carol Court that has sediment under the bridge that could be ponding water upstream (US) and meandering bottom downstream (DS). Picture 20 shows collection of debris at a utility crossing. The bayou is concrete lined from Houston St to DS of the I-49 Railroad bridge as shown in pictures 27A and 29B, but 29B also shows the ponding of water caused by a higher earthen channel bottom at the end of the concrete lining. Picture 35A shows the bayou with water at Eddie Williams Bridge, a CMP crossing the bayou and collecting debris in the Durawood plant in picture 36A, and double 9'x9' RCBC about half full in picture 37A. Pictures 39A shows a 78" steel pipe and picture 41 shows a 66"x102" CMPA in the Durawood plant. These pipes are just downstream of the double 9'x9' RCBC and could be severely restricting the flow. At Willow Glen there is a triple 10'x9' appears in good condition, and then the channel really opens up downstream. The replacement of the 2 pipe structures in the Durawood plant and channel improvements upstream of these pipes should be investigated.

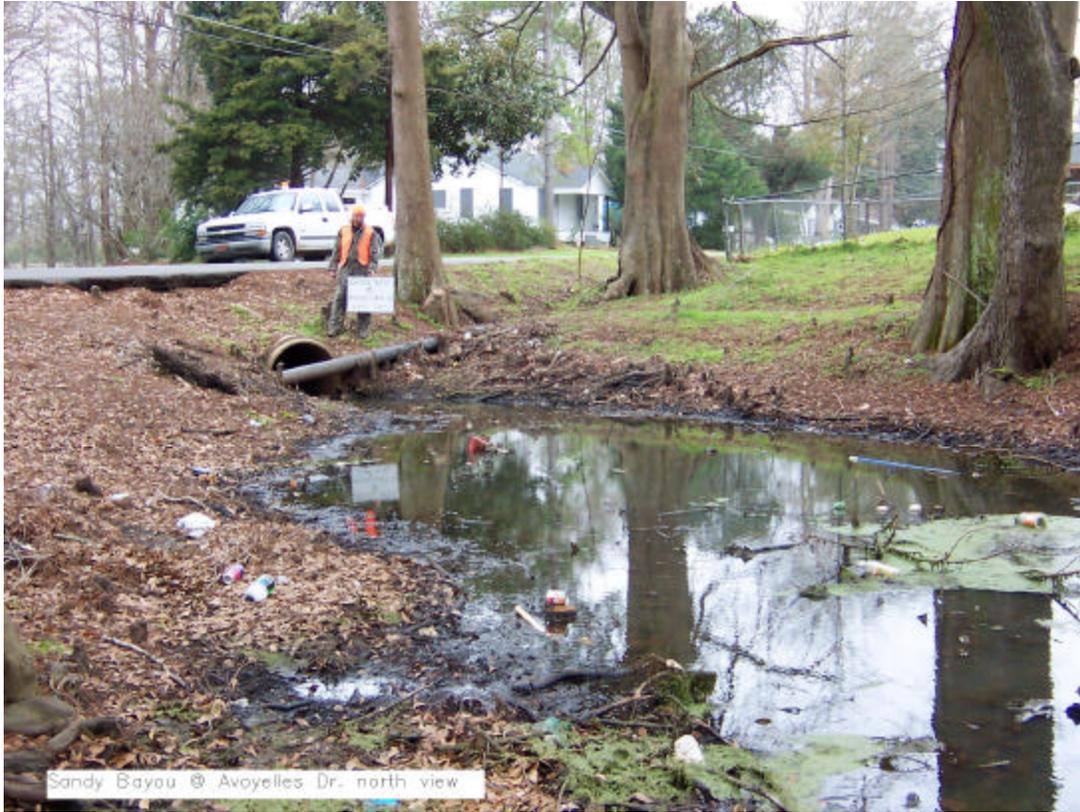
(4A) 4046+00 Avoyelles Dr (US View) – 42” RCP

As in Hynson Bayou, the upper end of Sandy Bayou appears to have standing water, vegetation, and silted channel causing inefficient flow through drainage structures (see pictures 4A, 5A, 6B and 7B). Picture 10B shows the outlet under Daspit St and the inlet appears in good condition also as do the pipes at Bennett St. Pictures 11A and 11B show the inlet and outlet of the pump structure at the connection with Chatlin Lake Canal. Channel improvement from Richmond Dr upstream should be investigated, as should the efficiency of the pump structure at Chatlin Lake.
