**Alexandria Site Visit**  
**Robert Reed**  
**March 28, 2006**

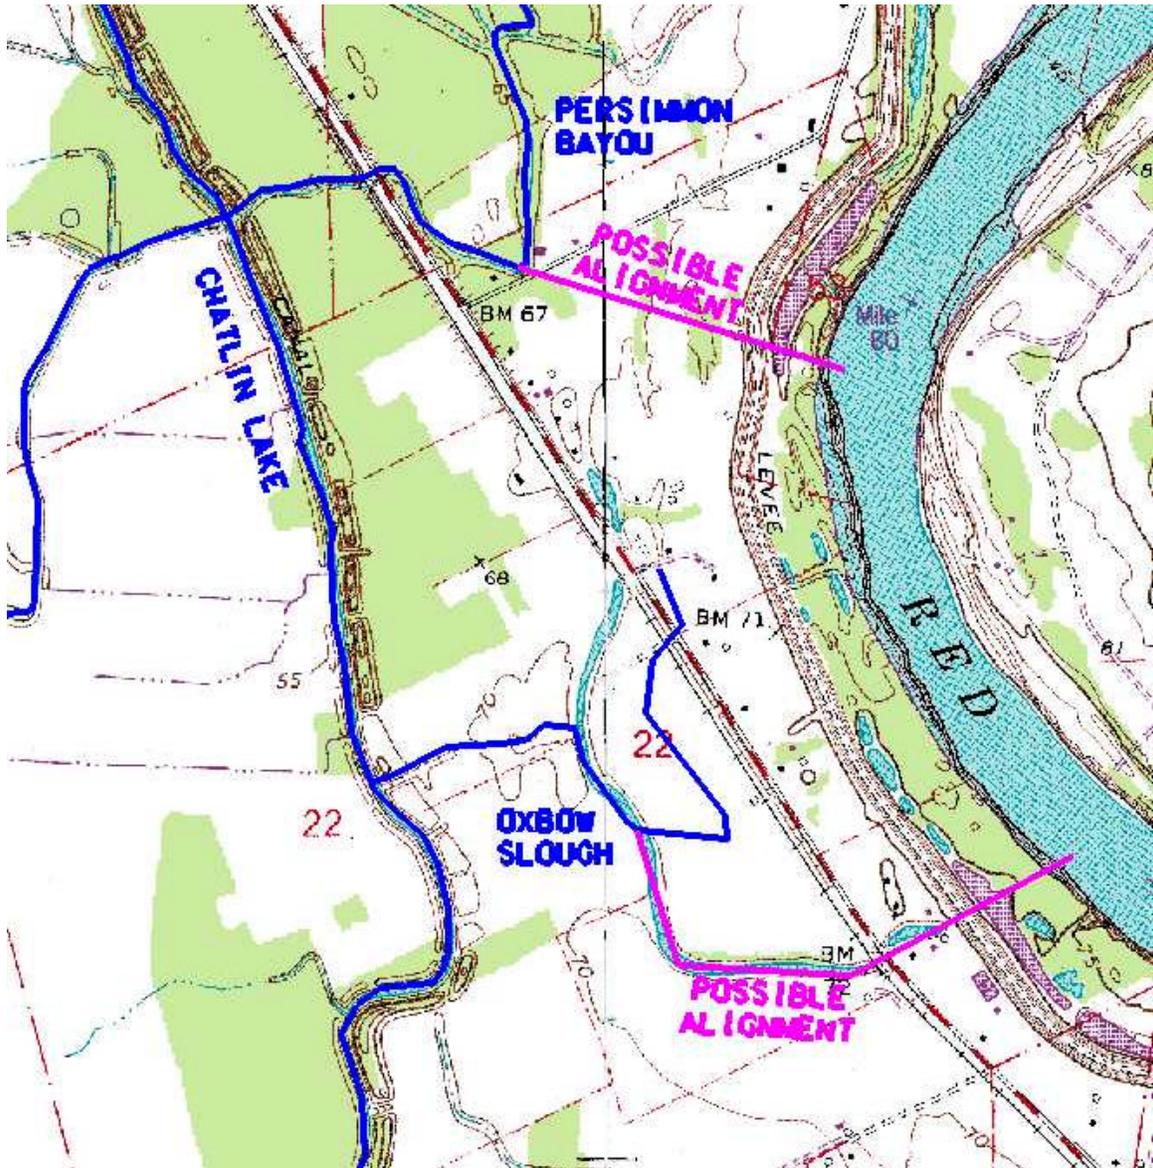
QUAD in vicinity of Short Diversion

I also made a visit to the area in the vicinity of the Short Diversion (pumping) where the Red River appears closest to Chatlin Lake. At each end of the “oxbow slough” I found small pipes under the railroad and a submerged pipe at the northern end under Hwy 1, but was unable to find a pipe under Hwy 1 at the southern end. It was most likely submerged also. I was unable to investigate the slough on the western side of the railroad due to fencing and wet conditions. Another possible alignment option for the Short Diversion (pumping) is along Persimmon Bayou. There is a large existing railroad bridge over Persimmon Bayou and double 8' x 8' under Hwy 1.
